**10 May 2018**

**FRESHWATER ECOSYSTEMS SITE SCAN FOR "DURBANVILLE GARDENS"  
ASSISTED LIVING RESIDENTIAL DEVELOPMENT PROPOSAL**

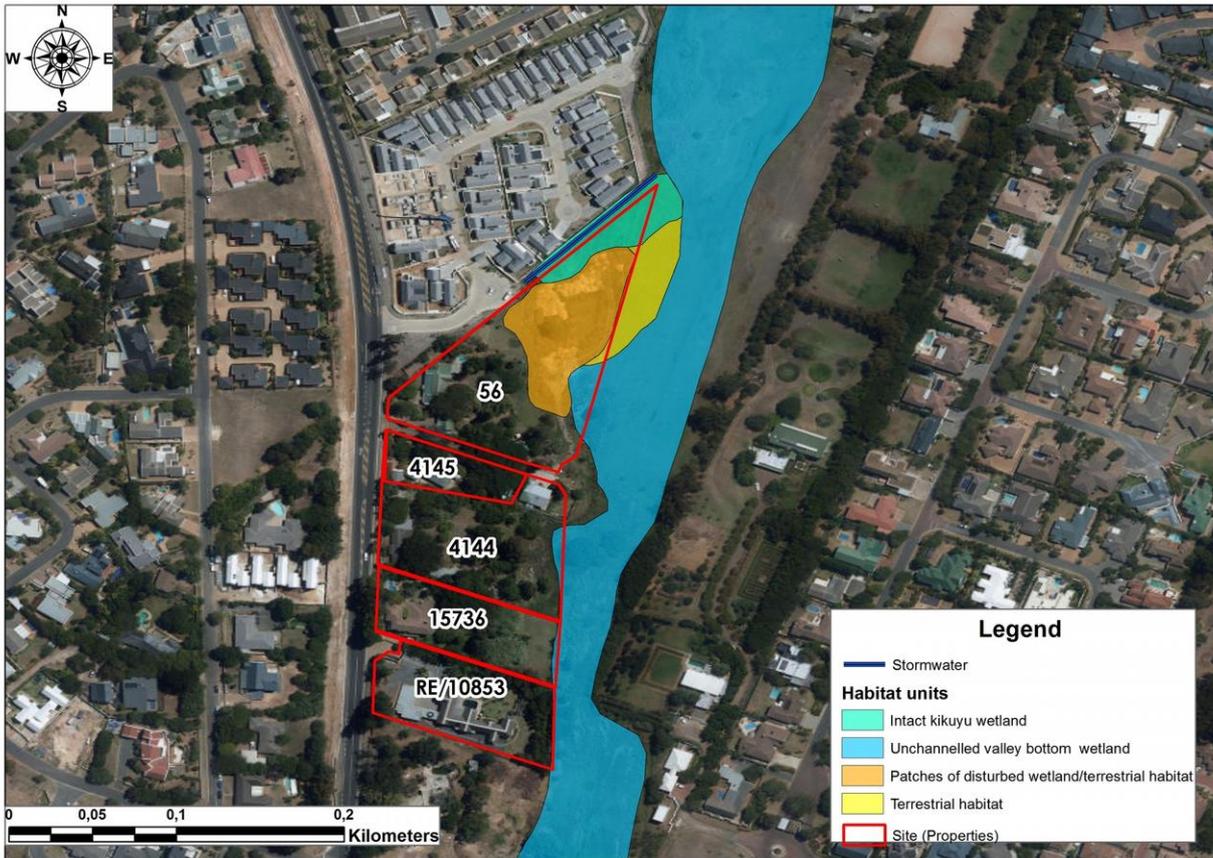
**Figure 1:** Map of the wetlands and other habitat units that were delineated on the proposed development site by the Freshwater Consulting cc

During the fieldwork undertaken by the Freshwater Consulting cc, it was confirmed that a valley-bottom wetland is present in the Open Space area to the east of the site and that this wetland does extend onto the proposed development site in places along the eastern boundary (as shown on the map of Habitat Units in **Figure 1**). The portion of this wetland located adjacent to the site, which was presumably an unchannelled system in its natural reference state, was observed to be highly degraded in terms of its present ecological condition. Impacts include, *inter alia*, hydrological alterations in the catchment and within the wetland (affecting the within-wetland distribution and retention of water), topographical alteration, water quality impacts and transformation of the naturally-occurring vegetation within the wetland through disturbance and the encroachment of invasive alien plant species. Non-indigenous plant species that were observed in the valley-bottom wetland included *Pennisetum clandestinum* (Kikuyu lawn grass), *Acacia saligna* (Port Jackson willow), *Arundo donax* (Spanish reed), *Cyperus papyrus* (Papyrus reed), *Echium plantagineum* (Paterson's curse), *Verbena bonariensis* (purpletop vervain), *Salix babylonica* (English willow tree), *Populus* sp. (poplar tree) and *Eucalyptus* sp. (gum tree).

A relatively large portion of Erf 56 (RE) is highly disturbed, with evidence of excavation and dumping. Based on the present-day situation, it is very difficult to determine with a high degree of confidence whether this disturbed portion of the site was naturally a wetland area, with presence of current-day wetland indicators on this portion of the site being very patchy (as shown on the map of sampling/observation points in the **Appendix** included with the current letter-report). If this portion of the site was historically a wetland area, it would have been a seep wetland<sup>5</sup>. An ecologically functional but degraded seep wetland was identified in the northern corner of Erf 56 (RE) by the Freshwater Consulting cc (see map in **Figure 1**). This wetland, which feeds into the valley-bottom wetland located down-slope to the east, has a stormwater drainage ditch flowing through it and is dominated by a thick growth of Kikuyu lawn grass (*Pennisetum clandestinum*).

The main finding of the site scan by the Freshwater Consulting cc was that there is a small area of ecologically degraded wetland on the proposed development site, mostly located on a hill slope on site, mostly located on a hill slope on Erf 56 (RE). The majority of the on-site wetland consists of a seep, which feeds into a more extensive (but also degraded) valley-bottom wetland system located immediately to the east of the site, although there are small patches of valley-bottom wetland extending onto the site where there are portions of the site situated on the valley floor. The present-day situation, in terms of the location and approximate extent of wetlands on the proposed development site, as delineated by the Freshwater Consulting cc, is visually summarised on the map of habitat units in **Figure 1**.

The main rehabilitation interventions that are required for the valley-bottom wetland area situated to the east of the proposed development site are some reshaping of the contours to facilitate better connectivity between the small channel and adjacent valley floor, and the removal of non-indigenous vegetation. Some re-planting of naturally-occurring wetland vegetation is also likely to be required. It would be important to ensure that the rehabilitation strategy that is developed ultimately enhances the ecological value and functionality of the Uitkamp Wetland System, and does not have any negative impacts on this downstream wetland area of high conservation importance. If the above-mentioned recommendations were to be effectively implemented as part of the proposed development, resulting in improved ecosystem functionality and habitat integrity of the valley-bottom wetland area to the east of the proposed development site, it is anticipated that the development could have a net positive impact with regard to freshwater ecosystems.
